Report No. FAA-RD-71-3

# **TITANIUM FUSELAGE ENVIRONMENTAL CONDITIONS IN POST-CRASH FIRES**

**Constantine P. Sarkos**  
National Aviation Facilities Experimental Center  
Atlantic City, New Jersey 08405

**MARCH 1971**

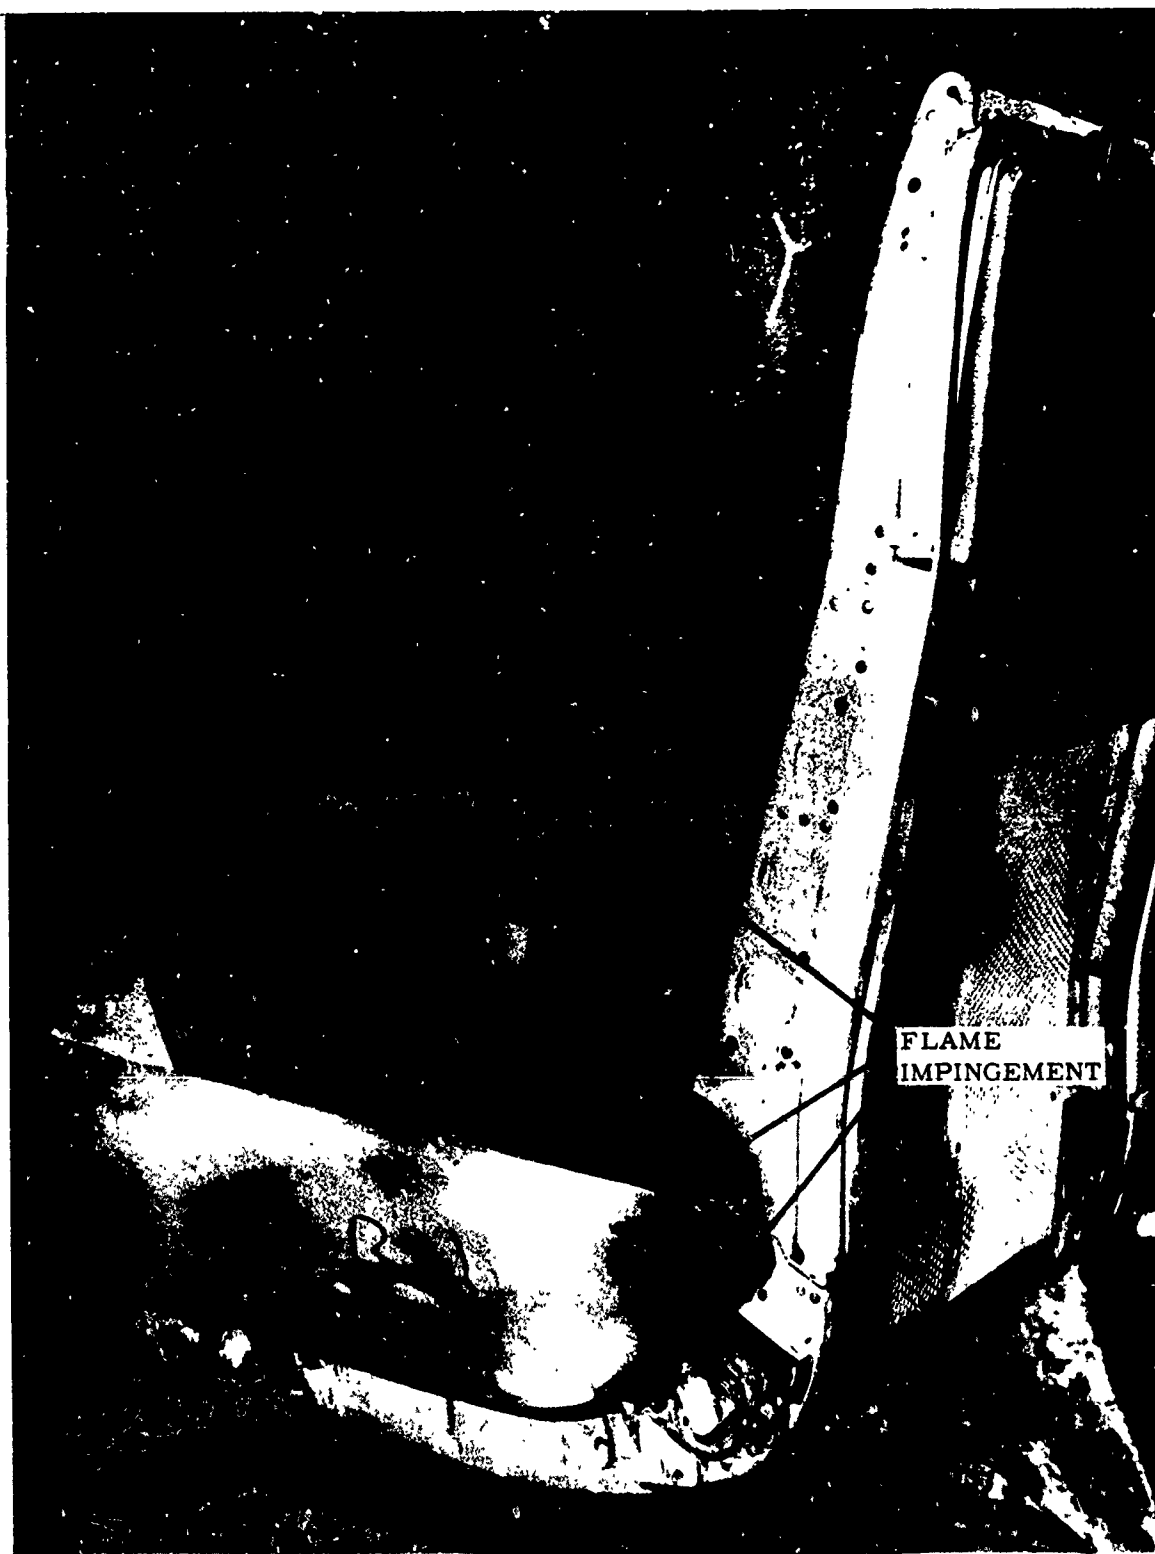
FIGURE 13 - DAMAGE TO AFT-MOST SEAT ADJACENT TO  
INTERIOR WALL

The first items removed from the fuselage were the seats and rug. Examination of the aft-most seat adjacent to the interior wall revealed evidence of flame impingement upon its side (Figure 13). The flame came from an interior panel interface which was adjacent to the burned seat area and burned away a small area of the seat cover; however, the fire did not spread from the area of flame impingement. Both the elastomeric armrest and the rigid foam siding also showed evidence of burning without any apparent flame spreading. The rug was burned away at the area immediate to the floor fire, but also without any noticeable flame spreading. This was also true of the rug areas struck by molten aluminum. The condition of the rug displayed the same trend as the hatrack and ceiling in that the damage to it decreased toward the forward end of the fuselage.

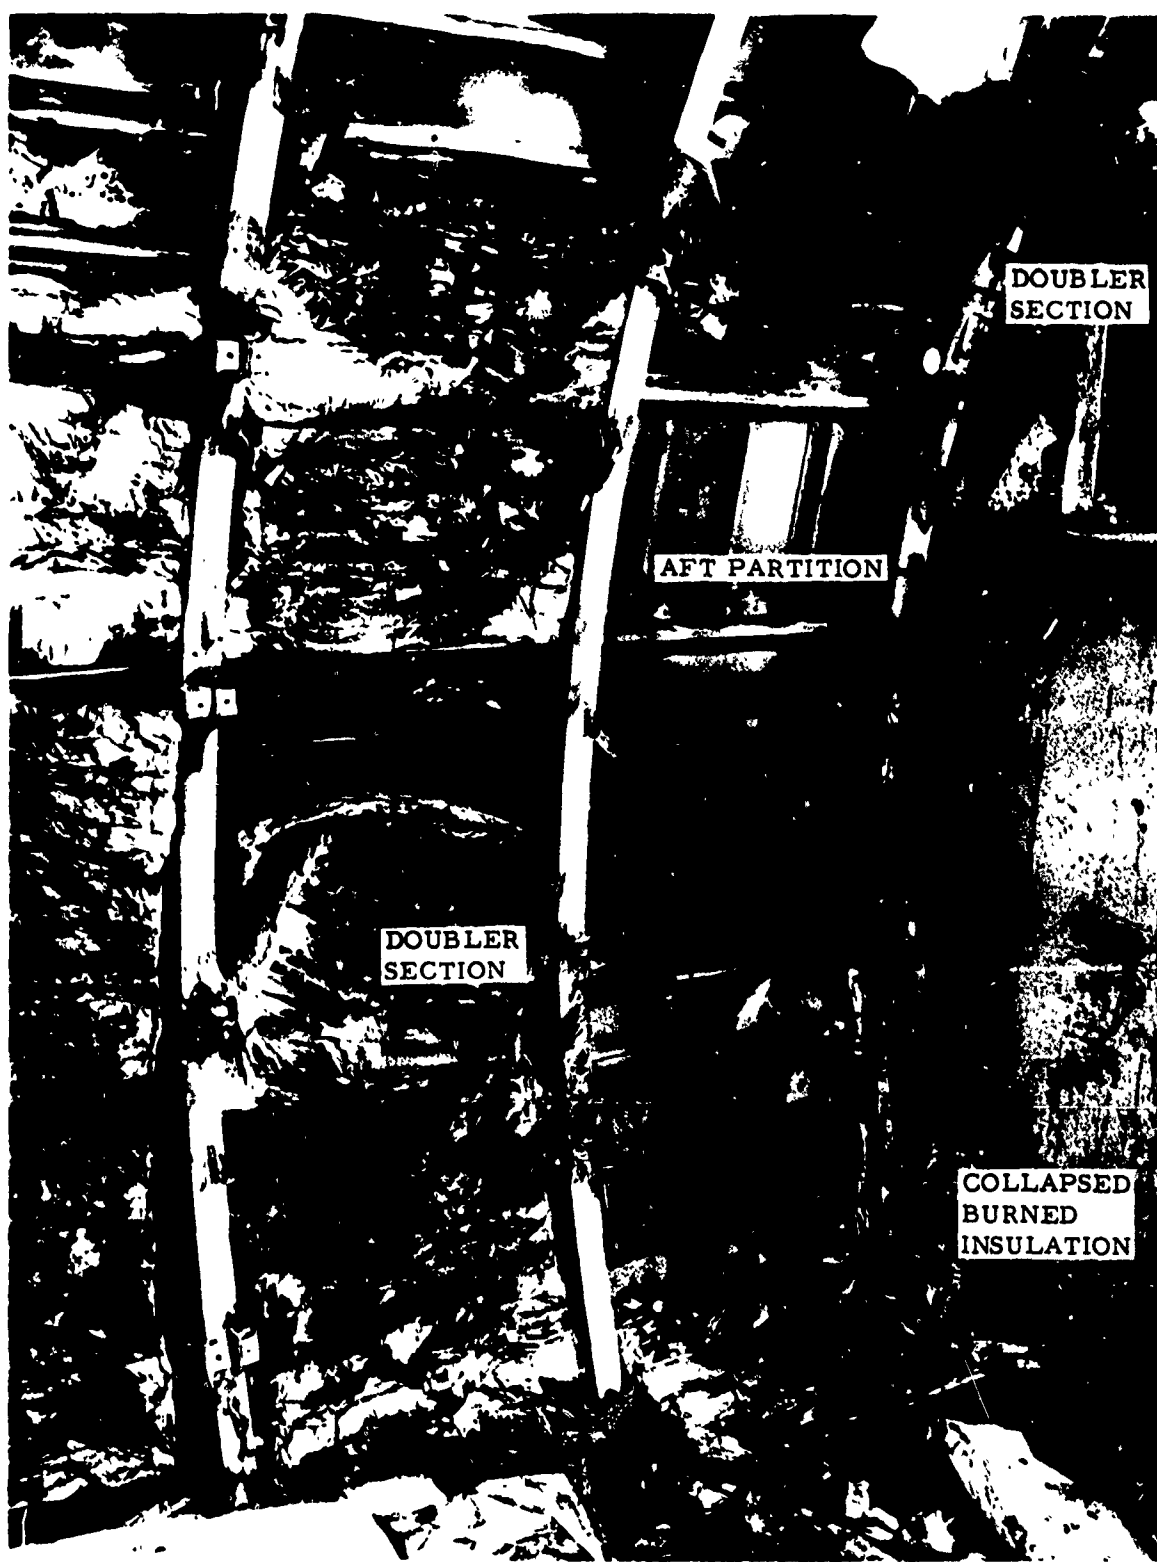
FIGURE 17 - BURNED SEALANT AND INSULATION NEAR AFT END

The next step in the examination of the test article was to remove the interior panels. Figure 17 shows the same section near the aft end as Figure 16, but with the interior panels removed. It was evident that severe burning of the RTV sealant and fiberglass (binder) insulation had occurred during the test. The degree of fire damage followed four trends: it was most severe (1) toward the aft end, (2) toward the cabin floor, (3) in the vicinity (especially above) of the RTV-covered doubler sections, and (4) toward the interior panel interfaces. The first two trends are clearly discernible in Figure 17, while the third trend is better illustrated by the closeup shown in Figure 18. Immediately above the RTV-covered doubler section the insulation was burned away, especially near the panel interface where the oxygen necessary for combustion could be obtained from the cabin air. It appears as if the RTV ignited first and acted as an ignition source for the burning of the insulation. Another closeup better displays the fourth trend (Figure 19). Although it is not clearly distinguishable in this black and white photograph, the insulation adjacent to the center former was unburned, while the insulation near the outer formers (panel interfaces) was severely damaged. Also, the RTV used on the formers as an adhesive was burned off the outer former, but that attached to the center former was unscathed. Clearly, the combustion occurred at the panel interfaces where oxygen was readily accessible from the cabin air.

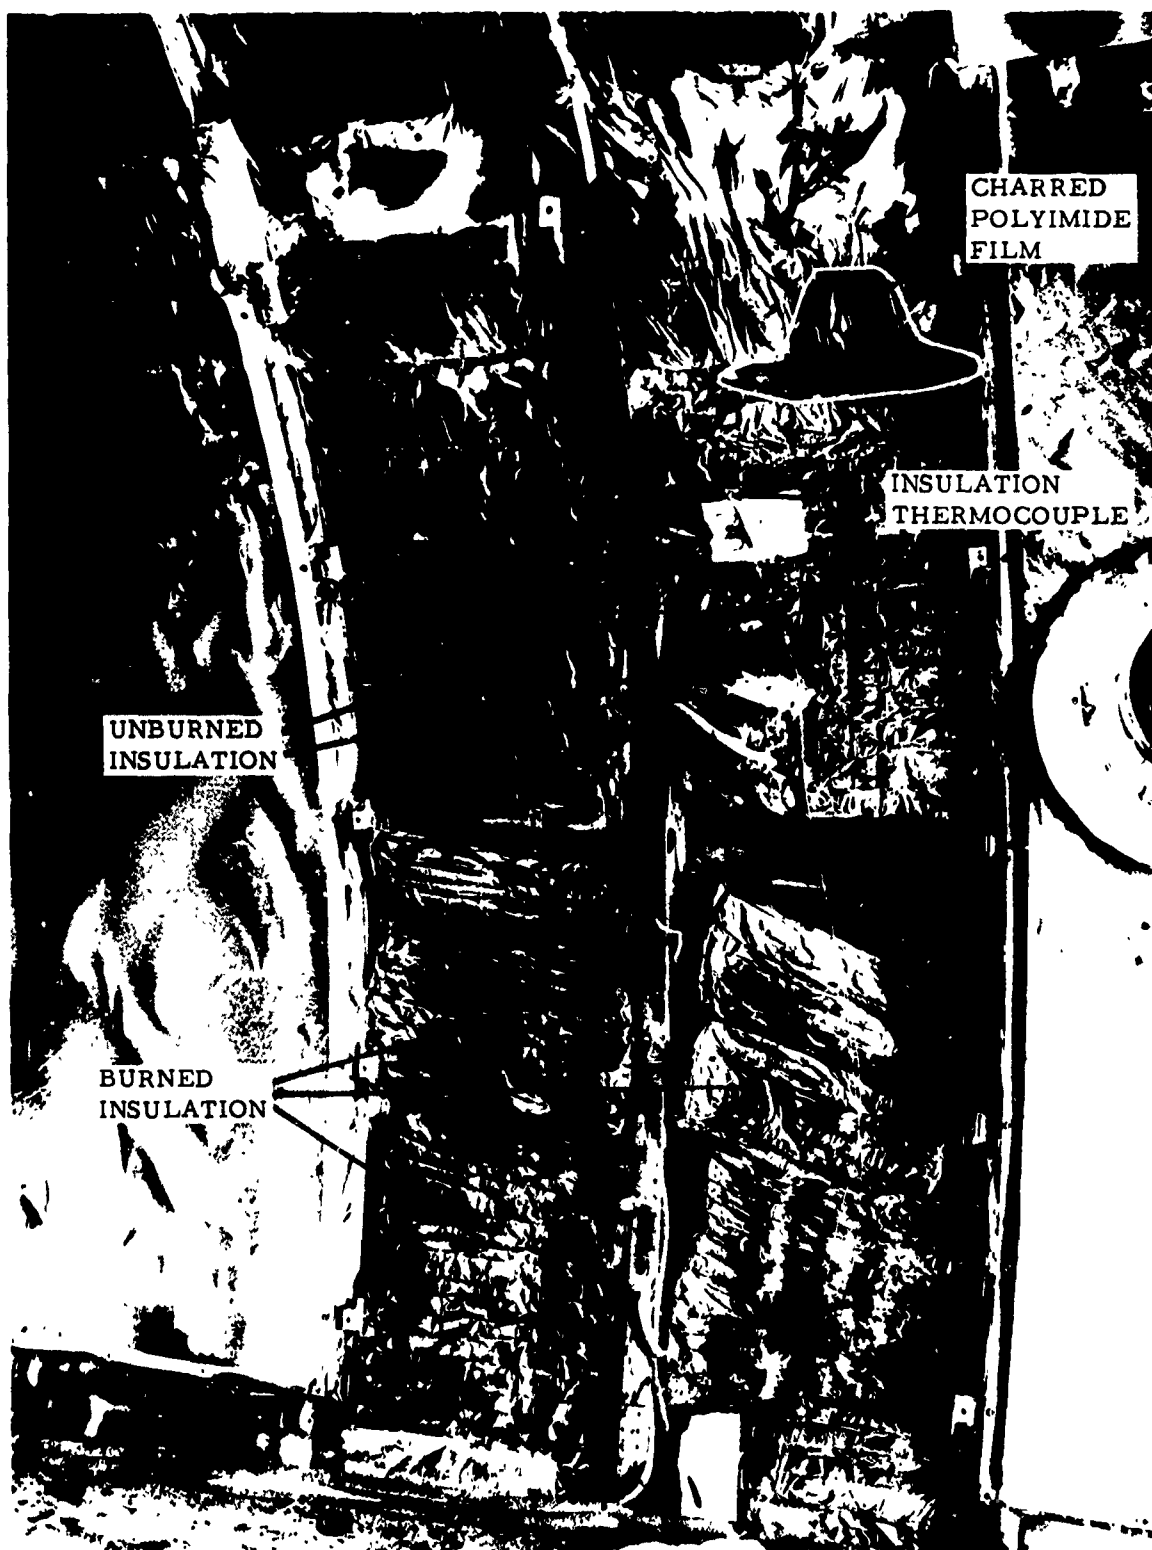
FIGURE 20 - CENTER INSTRUMENTATION SECTION WITH INTERIOR  
PANEL REMOVED

Figure 20 shows the interior panel removed from the center instrumentation section. The amount of burned insulation was considerably less than that at the aft end. The insulation immediately above the floor was almost completely burned, while that above the window level, except for a small area adjacent to an RTV-covered doubler section, was unburned. This behavior follows the previously outlined second and third trends. Examination of the insulation batt adjacent to the doubler section

revealed that the polyimide film facing the titanium skin was severely charred, while the adjacent fiberglass was not damaged. The RTV coating on the doubler section was completely decomposed, with only an insignificant amount of flake remaining. The RTV sealant decomposed and burned more readily than the fiberglass insulation, and was probably the major contributor to the cabin flash fire. Removal of the interior panel from the forward instrumentation section revealed that all of the insulation and RTV sealant were unburned. Thus, examination of the three instrumentation sections indicated that the fire damage to the RTV sealant and fiberglass insulation occurred in proportion to the severity of the external fire.
